MARINE ACCIDENT REPORT

**RAMMING OF THE
POPLAR STREET BRIDGE
BY THE TOWBOAT M/V CITY OF GREENVILLE
AND ITS FOUR-BARGE TOW
ST. LOUIS, MISSOURI
APRIL 2, 1983**

NTSB/MAR-83/10

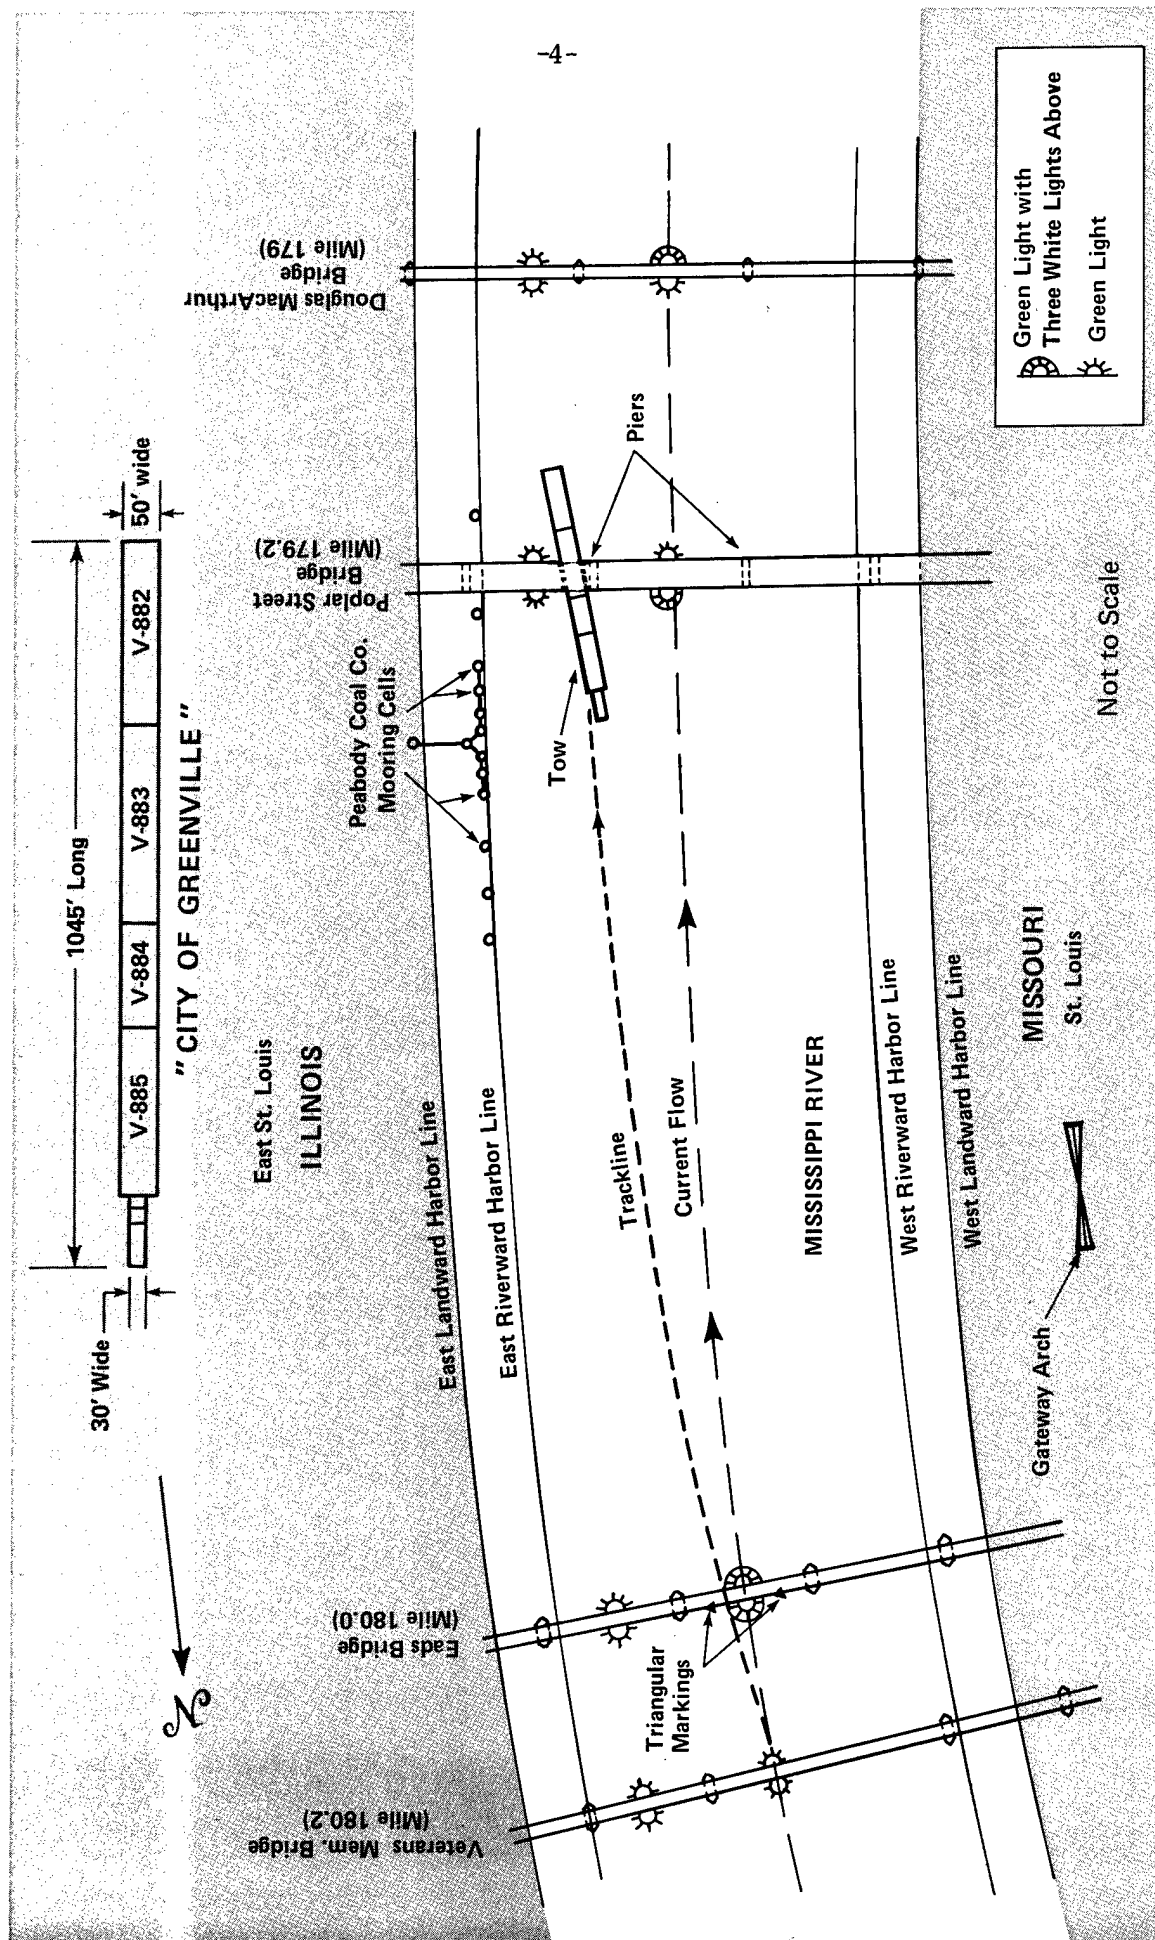
As the tow passed under the closely spaced Veterans and Eads Bridges (see figure 1), the operator recognized that a crosscurrent was setting the tow to the left. At some point the operator applied some amount of left rudder in an attempt to move the stern to the right to prevent the pilothouse or upper parts of the deckhouse of the towboat from striking the left side of the center arch of the Eads Bridge. This application of left rudder moved the stern to the right, causing the head of the tow to move to the left toward the Illinois side of the river. The steersman stated that, as the towboat passed under the Eads Bridge, the towboat was very close to the triangular-shaped mark which indicated the extreme left edge of the usable span of the bridge's center arch. 5/ (See figure 1.)

Figure 1.--Approximate trackline of the CITY OF GREENVILLE.

of the left side span. At this time the operator turned on the searchlight and illuminated the pier. This was his first use of the searchlight in navigating through the St. Louis harbor area. By the time the head of the tow entered the left side span, it was apparent that the starboard side of the tow might strike the bridge pier, and the operator applied right rudder in an attempt to move the stern of the tow to the left and away from the pier. This maneuver was not successful, however, and the starboard side of the tow, at about the point where the second and third barges were coupled, struck the right bridge pier of the left side span at about 2320. (See figure 1.)

The straight course that the operator steered toward the left side span of the Poplar Street Bridge resulted in a diagonal trackline across the river from a position near the center of the river toward a point on the left side of the river. The tow was, in fact, crabbing ^{16/} since it was cutting across the current of the river. As the tow proceeded downriver, it would have been necessary to bring the head of the tow to the left in order to continue to head toward the green lights of the side span, thus increasing the tow's angle to the current. The operator probably failed to recognize that the tow was crabbing, since he initially believed that he was steering for the main span in the center of the river. It is possible that the progress of the tow also could have been affected by the occurrence of a crosscurrent from the Illinois side of the river at some point below the Eads Bridge and above the Poplar Street Bridge. A crosscurrent would have required the operator to compensate by steering further to the left, which would account for a portion of the tow's relatively steep angle toward the Illinois shore at the time of impact.
